Flightfax®

Online newsletter of Army aircraft mishap prevention information

Mishap Review: AH-64D Ground Taxi

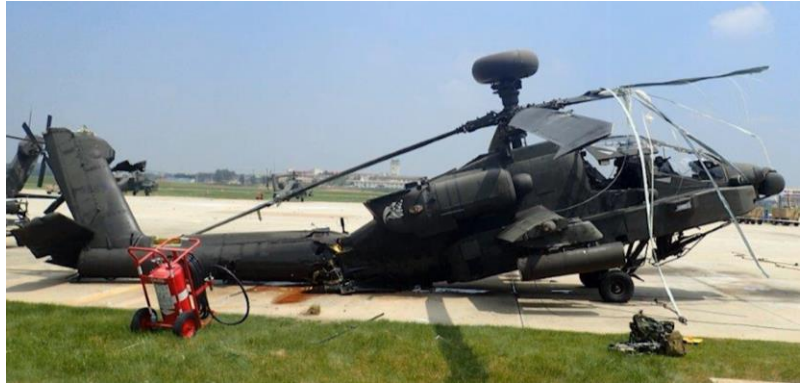
As the crew prepared to taxi, the AH-64D entered into an uncontrolled 135 degree left yaw / tail right and subsequently struck a wash rack curb as well as another parked aircraft.

During run-up the crew chief announced the tail wheel was unlocked and off axis. The Pilot in Command (PC) announced he would be backing up the aircraft and then attempt to lock the tail wheel as he pulled forward. At 1006L the PC initiated control inputs to move backwards and the aircraft began a left yaw. The aircraft entered into an uncontrolled 135 degree left yaw and subsequently struck a wash rack curb as well as another aircraft. The aircraft sustained significant damage as well as damaging nine other aircraft and causing minor injuries to personnel.

While controlling the aircraft heading with the pedals, the pilot on the controls must ensure pedal inputs are appropriate to maintain control of yaw. Use left or right pedal input to turn the aircraft in conjunction with applying lateral cyclic as necessary to maintain a level fuselage attitude. Rate of turn will be controlled by pressure and counter pressure on the anti-torque pedals. With the tail wheel unlocked, control the aircraft heading with the pedals and maintain a level attitude with cyclic. **Note:** If the tail wheel is unlocked during rearward taxi, the trailing arm tail wheel may swivel 180 degrees, causing momentary heading instability. Use caution so that the tail wheel does not caster around suddenly, as this puts an excessive load on the tail wheel cam.

Additionally, parking pads and utilization of areas such as wash racks or areas designated for maintenance operations should be in accordance with Unified Facilities Codes (UFC). Deviations from the UFC-design must be documented through written procedures that include a hazard assessment and mitigation measures.

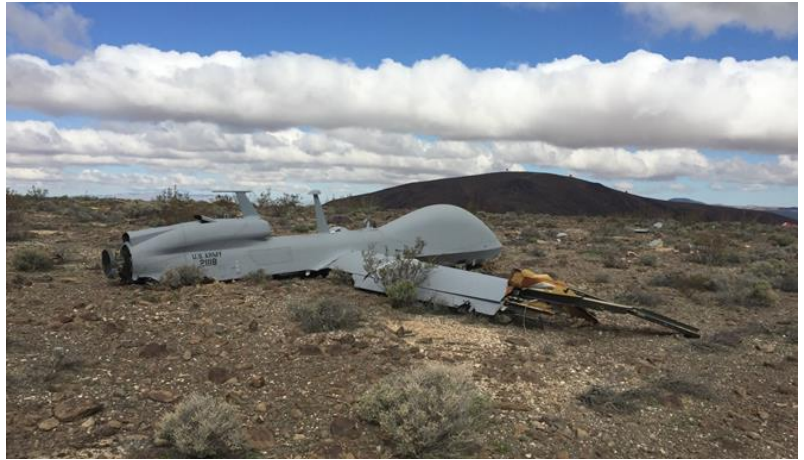
Mishap Review: MQ-1C Gray Eagle

During an emergency landing using the Automated Take-off and Landing System (ATLS), turning from base to final, the MQ-1C impacted terrain.

At 1643L, the MQ-1C conducted an automatic take-off and landing system (ATLS) take-off from the airstrip. Immediately upon take-off, the crew received a Warning/Cation/Advisory (WCA) indication for "Coolant Level Low." Following the emergency procedure of "Land as soon as possible," the crew continued to climb and established the required parameters for an ATLS land mode to be selected. The MQ-1C entered the 3 degree constant profile that was selected. As the aircraft continued its descending right turn from base to final, it impacted the ground at 1652L. Damage was assessed at Class A level.

- Terrain avoidance systems and warnings are disabled during ATLS land mode.
- While in ATLS mode, ALT AGL 2 represents height above touchdown. There is no display of actual altitude AGL of the aircraft.
- Laser altimeters are only on during the final segment of the approach to ensure safe landing.
- The ATLS runway survey only verifies the points on the runway. The manufacturer verifies that the survey is correct. The survey and the verification from the manufacturer do not account for terrain that may be in the flight path for the selected ATLS landing and take-off profile.
- There is no minimum terrain clearance established for ATLS landings and take-offs.
- Units should include in their reading file information regarding any ATLS profiles that do not provide adequate terrain clearance.
